For GOTTLIEB System 1 Electronic Pinball Machines

The Ni-Wumpf Replacement CPU Manual

Revision E

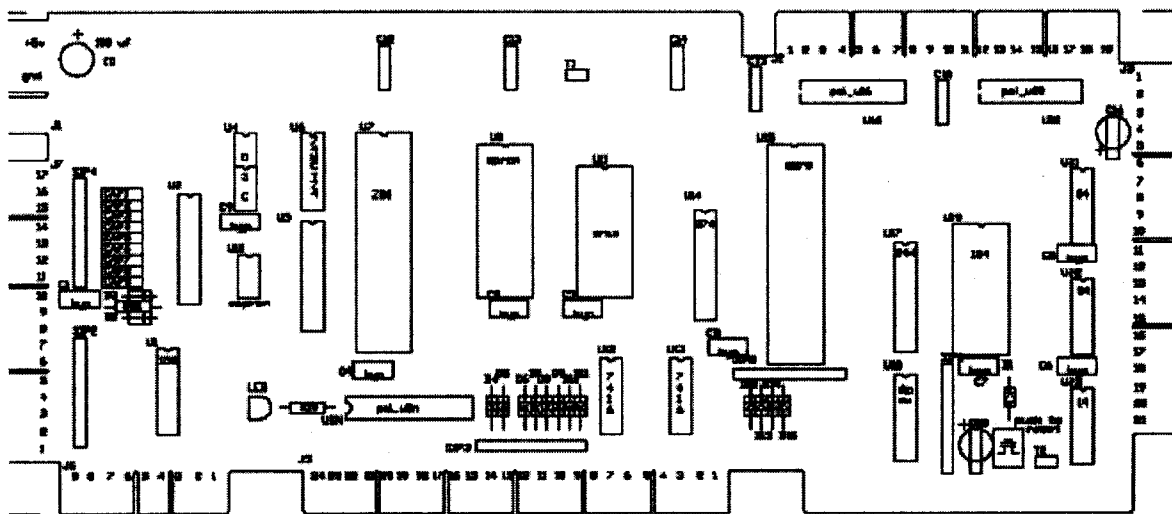
The CPU is oriented so that the component side faces out. The long side of the board with two connectors faces down, leaving the left side with two connectors also. On the upper left of the board goes the power

cable from the power supply (J1); lower left is the connector for the playfield switch matrix (J7). On the bottom side of the board to the left, is the connector to the front door switches (J6) next to the connector for the driver board (J5), to the right. On the right side of the board is half of the two connectors going to the displays. To install the display cables, connect the lower of the two cables (J3), to the connector on the left, fold the cable over the top of the board, and connect the upper cable (J2), onto the top-most connection..

Figure 1 - Ni-Wumpf replacement CPU showing connector designation.
